Manhole Inspection Summary

Manhole # S05EE2014MH

Insp Date: **7/17/06 8:03 AM**

Location Address: **2803 BARTOL AVE**

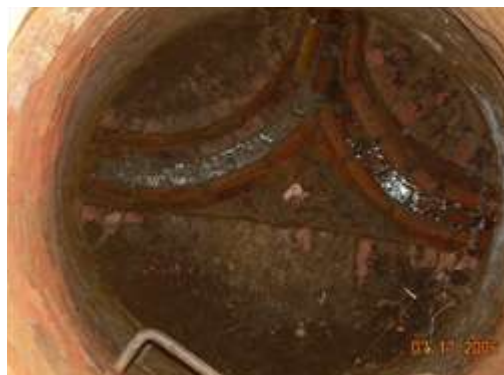
Top View

Adjustment, Corbel, and Barrel infiltration.
Bench debris.

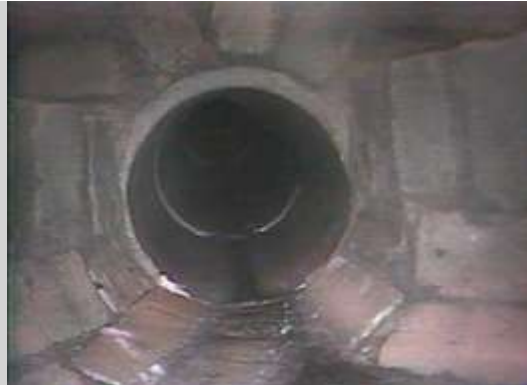
8 in. Circular Gravity Sewer Pipe Out @ 12 O'Clock

Infiltration: **Evidence** Pipe Seal Cond: **Unknown**

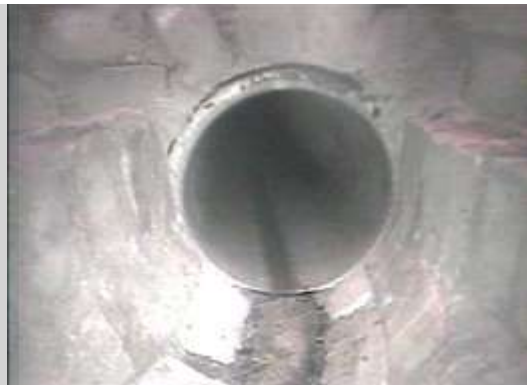
8 in. Circular Gravity Sewer Pipe In @ 3 O'Clock

Infiltration: **Evidence** Pipe Seal Cond: **Unknown**

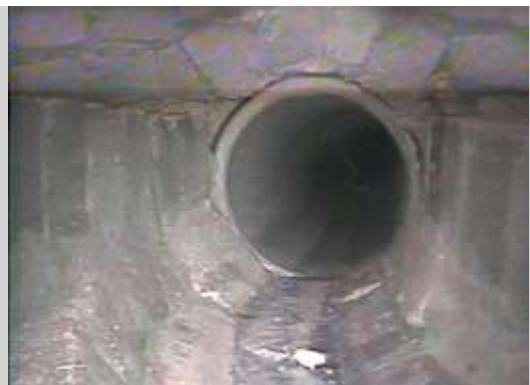
Pipe In @ 9 O'Clock

Infiltration: **Evidence**
